Annex B: Example of recent localised flood mitigation effort

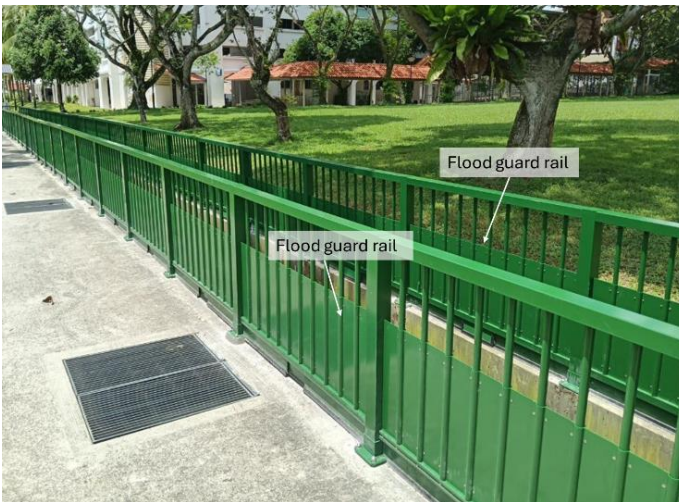
Yishun Ave 7 is a flood risk area that last encountered a flash flood in April 2025. PUB identified the cause of flooding to be an undersized culvert across Yishun Ave 7 and the downstream roadside drain up to Yishun Street 22, which created a bottleneck causing water to back up in the drain and flood the road.

Downstream measure: Flood boards were mounted onto drain railings to prevent overspill of stormwater from the drain onto adjacent land.
